RADC-TR-72-148  
Technical Report  
July 1972

## ELECTRICAL OVERSTRESS FAILURES IN SILICON DEVICES

**Clyde H. Lane**

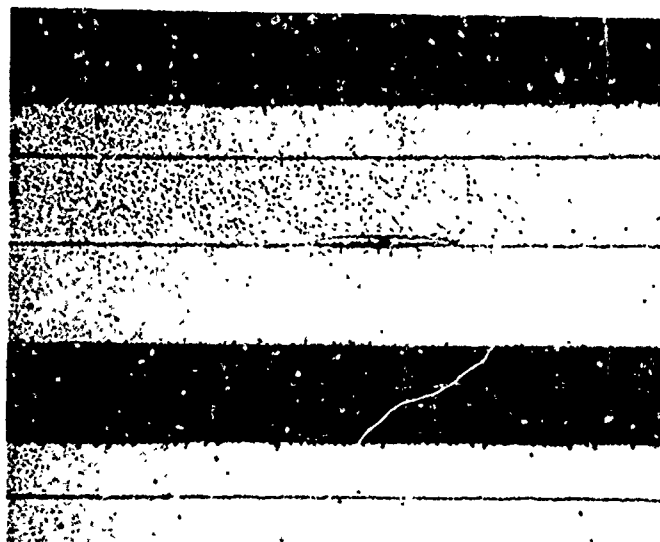
Figure 8  
Start of a Zap

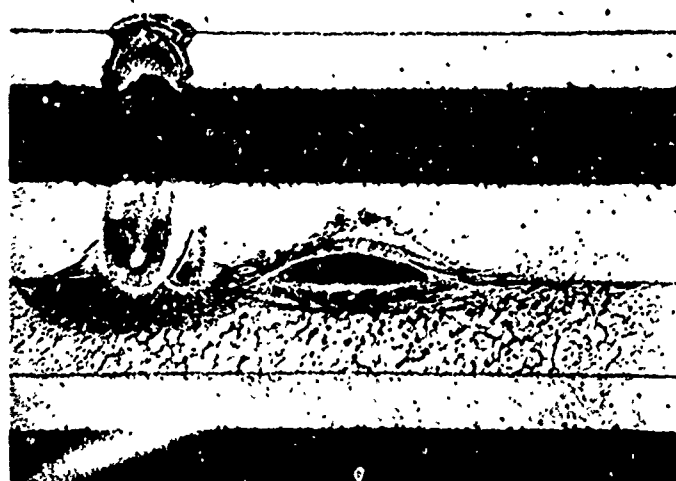
conspicuous grain growth. After the third pulse, Figure 9, the aluminum has completely pulled away from the contact step, there is considerable damage in the contact area and a flashover has occurred adjacent to the initial damage. The flashover did not short the device.

Figure 9  
After Three Pulses, Severe Aluminum  
Degradation and a Flash Over,  
But No Short

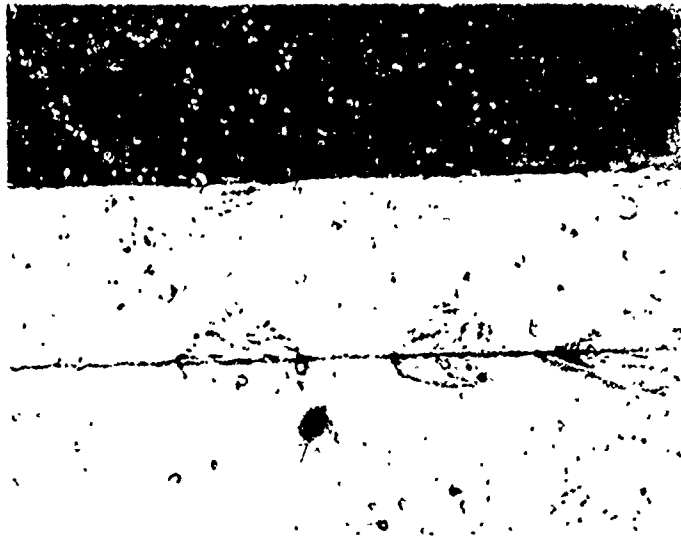
In second breakdown it is known that filaments form which conduct high currents. Evidence for such conduction filaments, in addition to the flashover was seen at both positive and negative electrodes. Figure 10 is a photograph showing traces of conduction filaments. These traces were produced by the high temperature generated by the conduction filament beneath the oxide, which caused aluminum on top of the oxide to melt and recrystallize along the path. There are two paths in this photograph. In spite of the feeling that the zap should initiate where all the damage is being done, ample evidence exists to prove that the zap actually does go from the positive to the negative side regardless of the silicon type. In Figure 11, for example, while extensive damage is seen at the negative side, it is obvious that aluminum has moved from the positive electrode. First, it is wider on that side, and second, the highest temperature for the longest time was experienced above the zap on the positive side as evidenced by the greater aluminum melting (black area) and flow.

Figure 10  
Evidence of Conduction Filaments  
Beneath the  $\text{SiO}_2$ , Negative Side

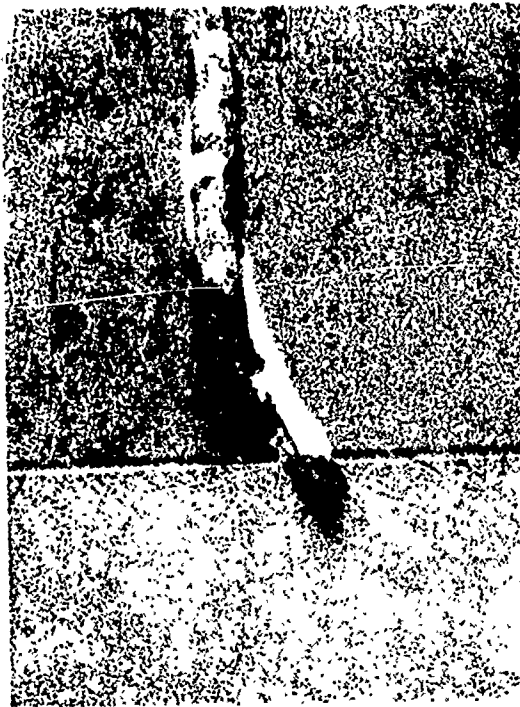
the silicon, changing the n-type to p-type. Figures 12 and 13 give the results. In Figure 12 one sees two paths, a black, hazy, straight path and a serpentine path which appears to contain aluminum. In certain areas the aluminum looks thick. There is no channel beneath the hazy straight path, but a roughly semicircular channel filled with polycrystalline material forms the serpentine path. Aluminum etch readily attacks material in the channel and gives the black region seen in Figure 13. Continued etching removes the white areas entirely. Surprisingly, the p-stained revealed a pronounced p-type area, six microns deep, exactly beneath the hazy path and continuous from it. Diffusion to that depth in the time allowed would require a temperature close to the melting point of silicon, but there is no evidence of damage at the surface to suggest this, and the oxide was not disturbed. The only other satisfactory explanation is alloying from a thin surface layer of Al - Si eutectic. After angle lapping, some chips were mounted for cross sections. Figure 14 shows such a section revealing the hanging drop shape of the zap channel. The black line from which it is hanging is 6000 angstroms of thermally grown silicon dioxide. Over the oxide one can see the aluminum metallization. Another section which was placed in aluminum etch can be seen in Figure 15. This is almost a hemisphere and aluminum has been etched out of the channel as well as from the surface of the chip. Several measurements of the maximum voltage applied before breakdown have average values of 155 and 211 volts for 30 and 58 micron

Double Path in Surface Short

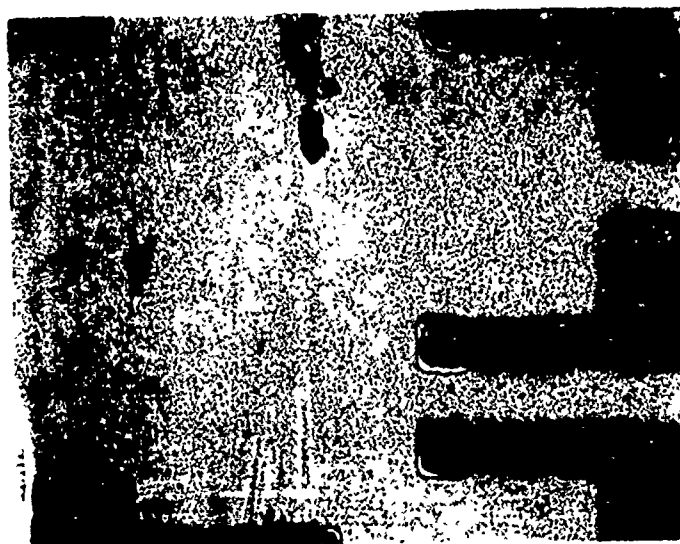
gold metallization also had a thin organic film on the oxide surface. It was alloyed at 340°C for 2 hours. The turnover and breakdown voltages were the same as for aluminum metallization to 0.5 ohm-cm p-type silicon. Figure 20 shows an incomplete zap involving gold. The same features characterize this failure mechanism as had been observed with aluminum, namely, greater heating on the negative side with obvious plasma formation and zap initiation from the positive side. Voltage was applied again and, as with aluminum, the initial spear did not lengthen but a new spear was generated. There was additional gold migration from the negative side during the second pulse. The extent of gold migration from the negative side exceeded that seen in aluminum contact metallization. The organic film in this case provided a nice thermo-graph seen as a hazy halo surrounding the fold spear. It was noticed that the gold does not take on a triangular shape at the tip as does aluminum, and it may not follow a 211 direction at all, as the aluminum often does. Figure 21 shows a gold protrusion from the positive side. This is the very start of a zap. More power would have pushed that gold out in the form of a spear toward the negative electrode. Gold was removed from the surface for this photograph showing that gold is beneath the silicon dioxide surface. The discolored region is the result of incomplete removal of the overheated thin organic film.

Figure 20  
Multiple Partial Zap Paths From the  
Positive Electrode and Slow Gold  
Migration from the Negative Electrode

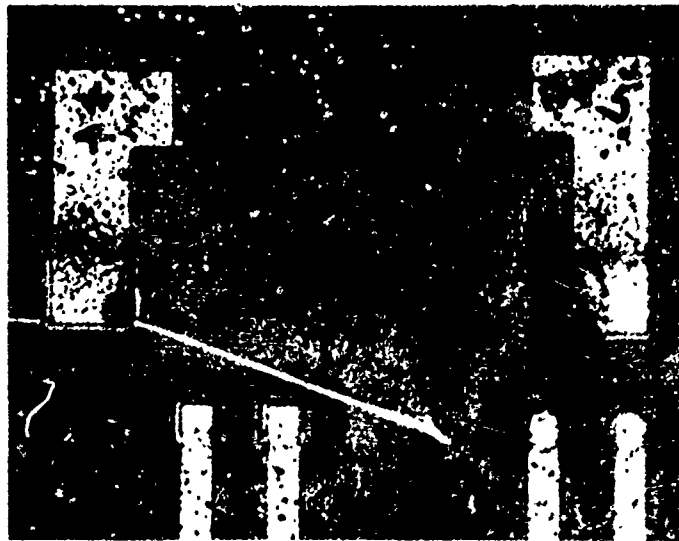
Figure 23  
Partial Zap in 211 Direction  
on 950°C Oxided Wafer

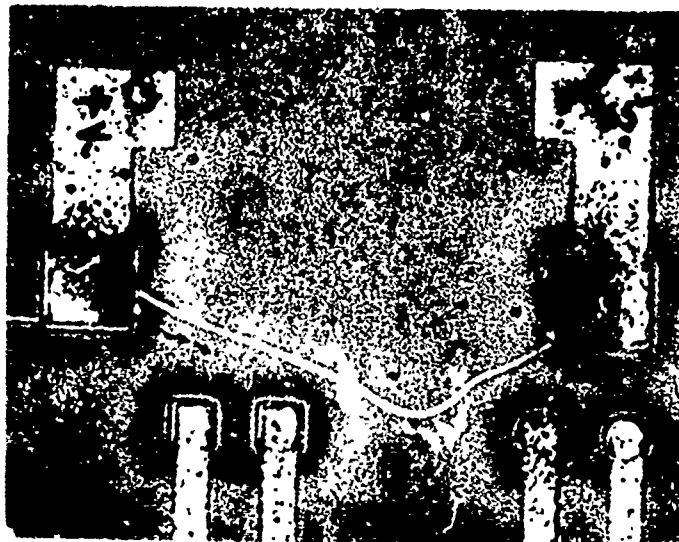
Figure 24  
Complete Zap Between the  
Electrodes of Fig. 23
